## Final Project Report- MICRORED

2022:01382 - Unrestricted

Microplastics,  
aquaculture, HDPE  
feeding pipes,  
pneumatic conveying,  
pipe wear, pellet  
degradation

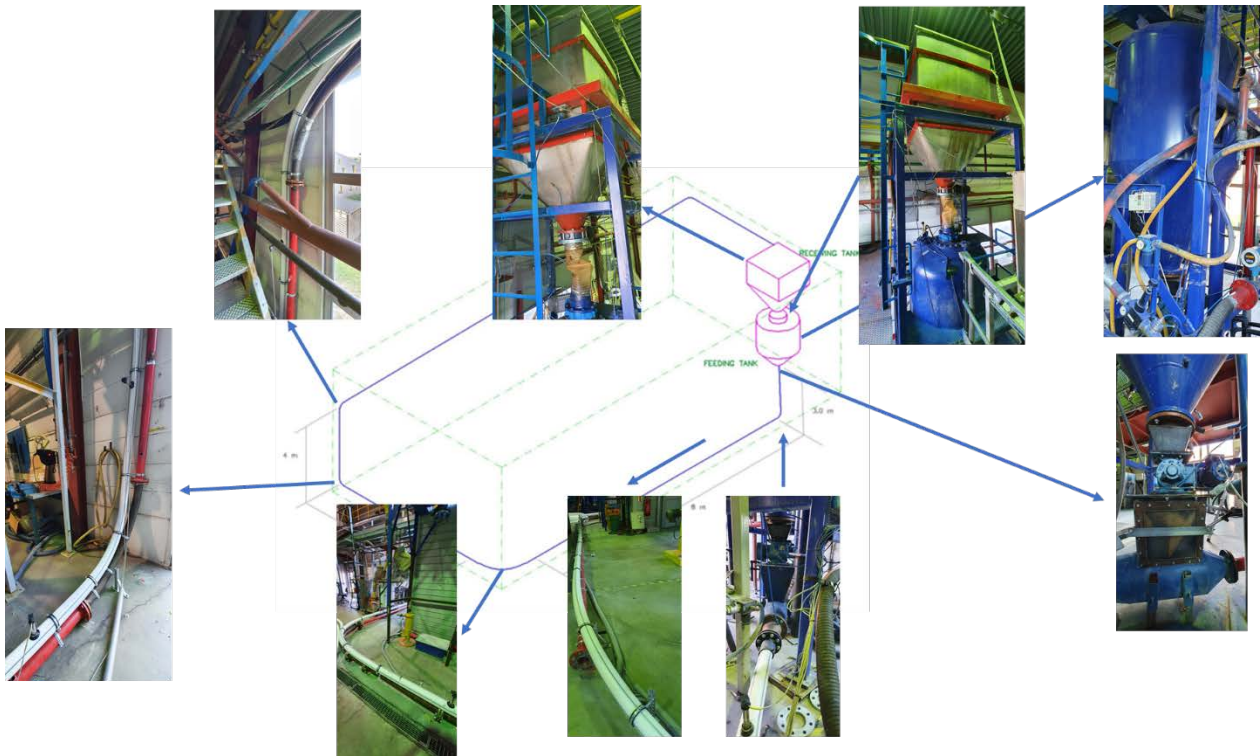
**Figure 5: Schematic view of the conveying test rig (A), pictures showing different parts of the test rig and equipment (B)**

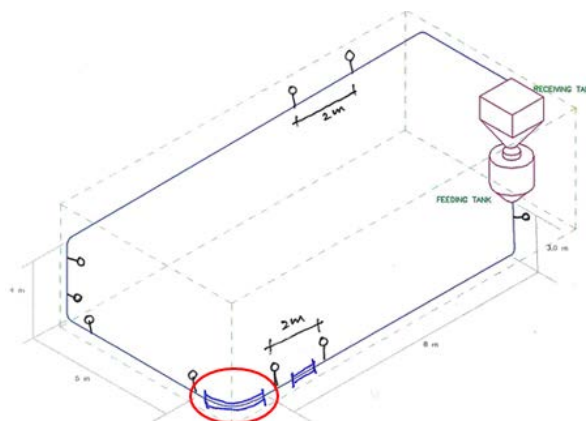
**Figure 6: Erosion is studied in the 90° bend marked by the red circle.**

The degree of erosion is typically measured gravimetrically, meaning the specimen is weighed before and after exposure to erodent. In this study, erosion is studied in one of the 90° bends (Figure 6) that can be detached from the pipeline and weighed before and after the tests to determine the weight difference.

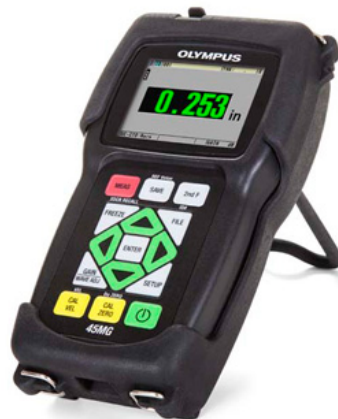
Figure 8: Olympus 45MG Ultrasonic Thickness Gauge<sup>1</sup>.

A hand-held device for the measurement of pipe thickness, Olympus 45MG Ultrasonic Thickness Gauge, was used to determine pipe thickness at specific locations along the bend piece where erosion was studied. The instrument has an accuracy of +/- 0.10 mm with a standard resolution of 0,01 mm.

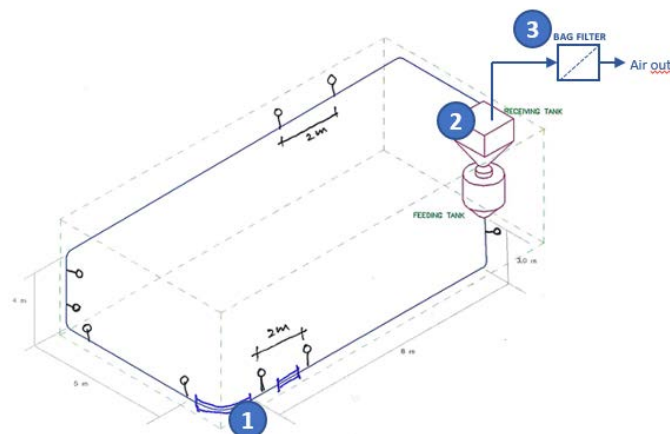
**Figure 10: Illustration of sampling points for analysis of produced MNPs during erosion tests.**

Samples for analysis of MNPs were taken after erosion tests from three locations as illustrated in Figure 10. Erosion tests resulted in a significant pellet degradation and formation of an oily dust deposit inside the feeding pipes. The sample of the deposit was taken directly from the inside of the bend piece after detaching it from the line. The cleaning solution after it has been used for cleaning of the bend piece was also used as a sample for further analysis of MNPs. Further a sample of used pellets has been taken from the receiving tank. The fine dust collected in a container below the bag filter was also used as a sample for analysis MNPs.

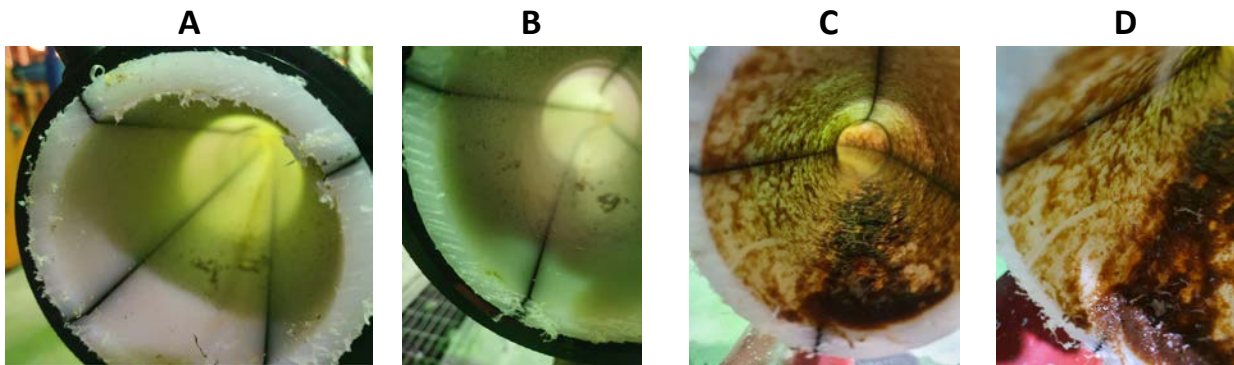
**Figure 11: Photographs taken after dissecting the pipe bend for the erosion study: a view into the straight line before the bend (A), into the bend inlet (B), into the bed outlet (C) and into the straight section after the bend (D).**

As explained in Section ii, once the pressure tests were finished, the pipeline was opened by cutting out a bend segment (Figure 11A). Flanges were mounted on both sides of the used bend segment and at both ends of the adjacent straight pipe sections so the bend piece could be re-connected with the pipeline. An additional bend segment with flanges was fabricated using a virgin pipe (Figure 13). The detachable bend segments were used in subsequent erosion tests to estimate the degree of erosion during pneumatic transport of fish feed. Pressure transducers are installed before and after the bend to monitor pressure over the bend during the tests.

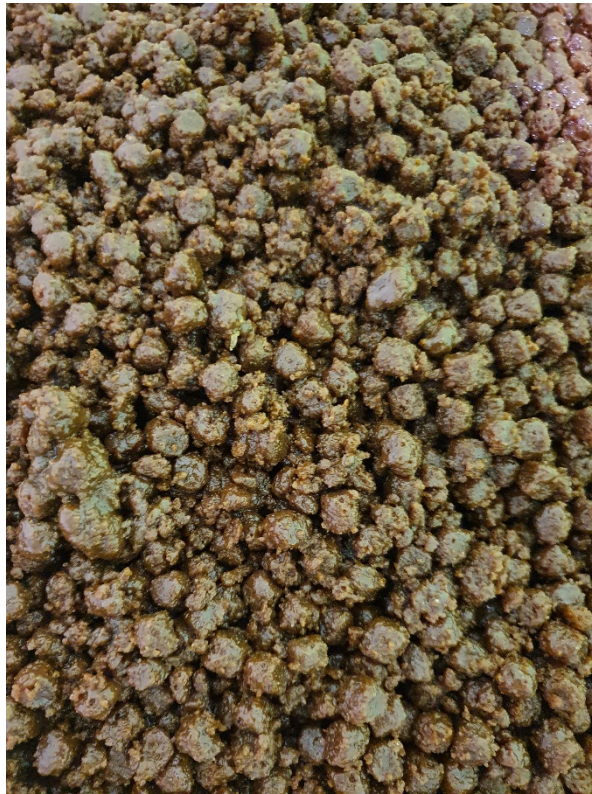
**Figure 16: Degraded pellets after seven rounds of transport in the pneumatic conveying rig, the size of the pellets is reduced, and pellet debris are apparent.**

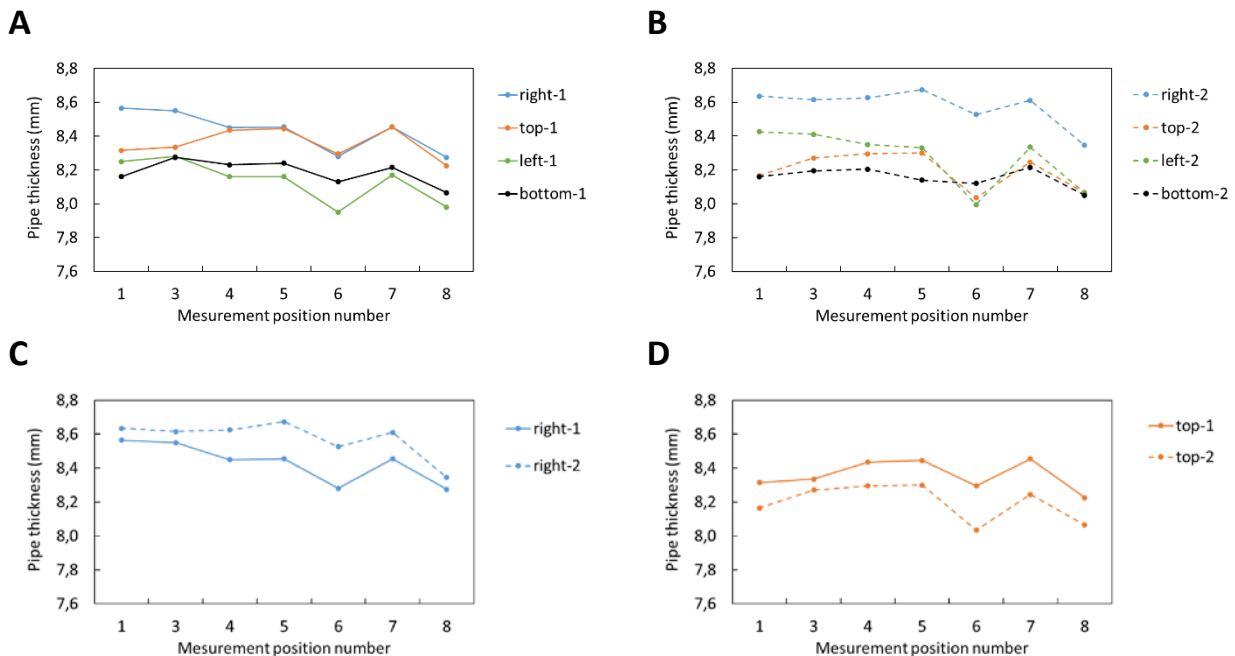
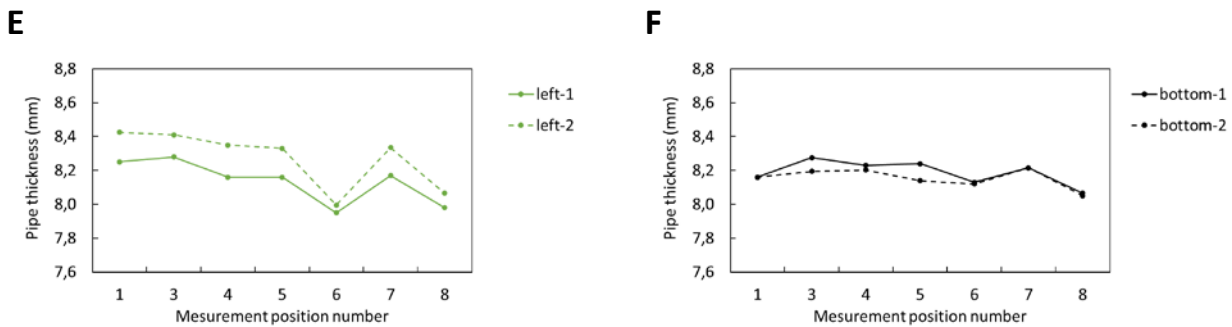
**Figure 19: Pipe thickness measurements at four positions around the pipe circumference (bottom, top, right and left side): in the legend right-1, top-1, left-1 and bottom-1 are the first measurements taken before erosion tests while right-2, top-2, left-2 and bottom-2 are the second measurements taken after erosion tests.**

Pipe thickness was determined at multiple points along the bend, as described in Section b.iv, before and after the tests when the bend was cleaned. The results are shown in Figure 19.

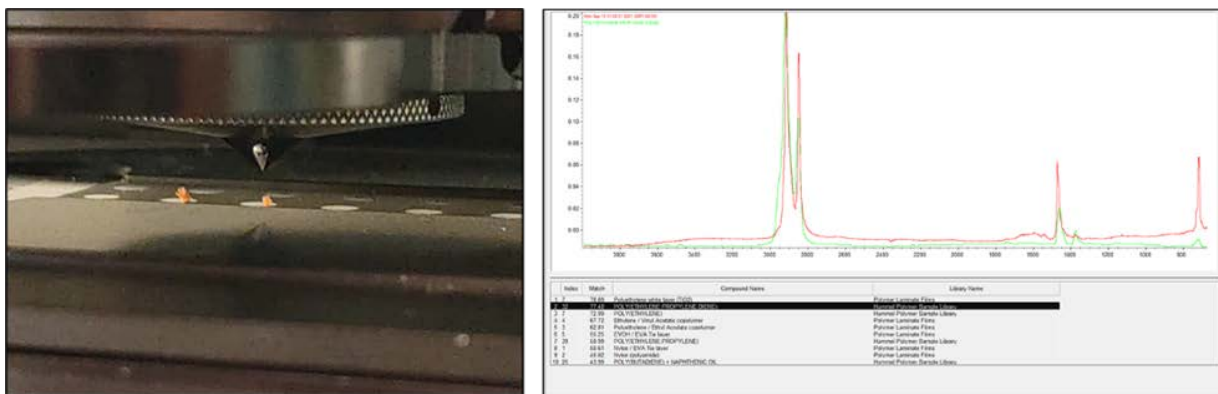
**Figure 22: ATR-FTIR Sample acquisition (left) and IR profile (right) acquired during the characterization of the cleaning sponge and identification exercise by comparison with Hummel IR polymers reference database.**

The ATR-FTIR analysis submitted to both a fragment of the cleaning sponge and a section of the feeding pipe identified Polyethylene (PE) as the constituent polymer in both cases (fig. 22).

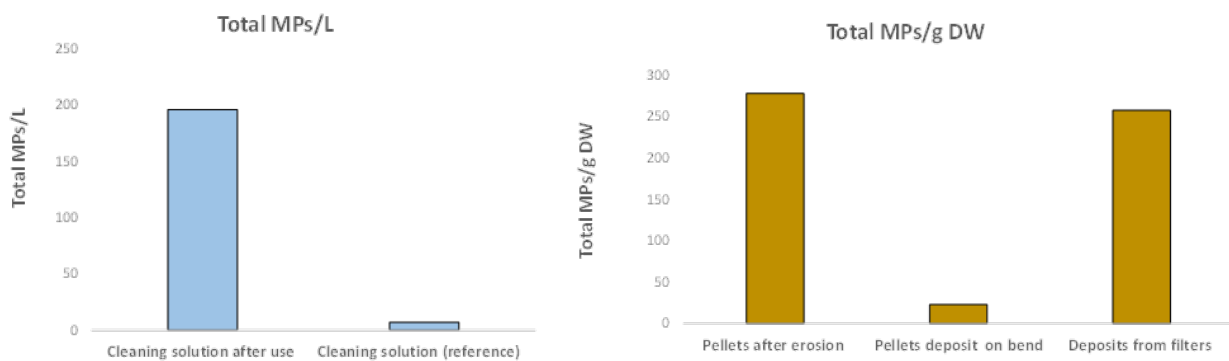
**Figure 25: Total amount of MPs identified in the analysed samples from the convey system experiment.**

The total number of microplastics in the samples varied significantly with the cleaning solution before its use (reference) showing 7 MPs/L and a significant increment after use (196 MPs/L). On a similar way, the semi-solid and solid samples showed significant differences with lower levels observed in the pellet deposits on belt (23 MPs/g DW) and considerably higher amounts in the pellet's surfaces after the erosion processes (278 MPs/g DW, fig 25).

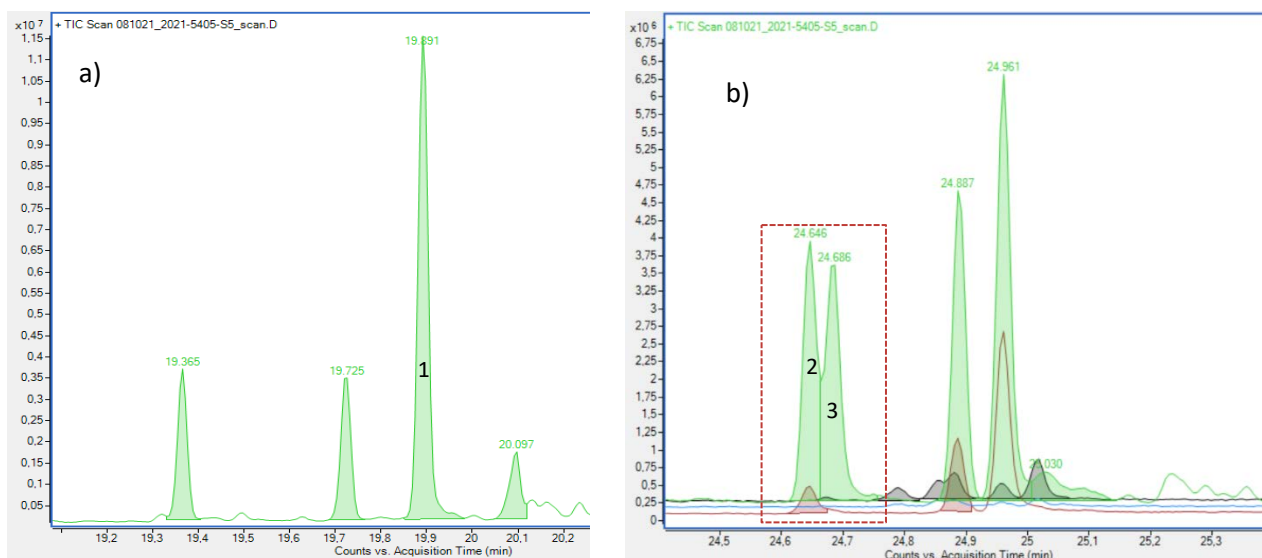
**Figure 27: Chromatogram showing suspect markers, i.e., peaks present in solvent extract only. a) Suspect marker 1 with RT 19.89 min. b) Suspect markers 2 and 3 showing with RT 24.65 and 24.67 min. In figure b) there were some low-intensity peaks present in the solvent extract (green), leachate (black), solvent extract procedural blank (red), and leachate procedural blank (blue), these are overlaid in b) to show that there is little to no interference with the suspect markers 2 and 3.**

The characterization of the HDPE tube using a non-target screening approach resulted in three suspect polymer-specific marker chemicals being identified: dibutyl phthalate, 2,4-bis(1-methyl-1-phenylethyl)-phenol, and 2,4-Bis(dimethylbenzyl)-6-t-butylphenol with 278, 330, and 386 *m/z* as respective characteristic ions. These chemicals were detected only in the solvent extract and not in the leachate sample, indicating that they are specific to the plastic tubing and do not readily leach. As such, they are potentially good chemical markers for the detecting the presence of nanoplastic in a sample. There were several chemicals detected in the leachate, however, further identification and characterisation of these chemicals were outside the scope of this study. The solvent extract and the leachates were then re-analysed with the targeted GC-MS method (using single-ion-monitoring) for validation of these chemicals and their presence in the solvent extract only, see Figure 27.

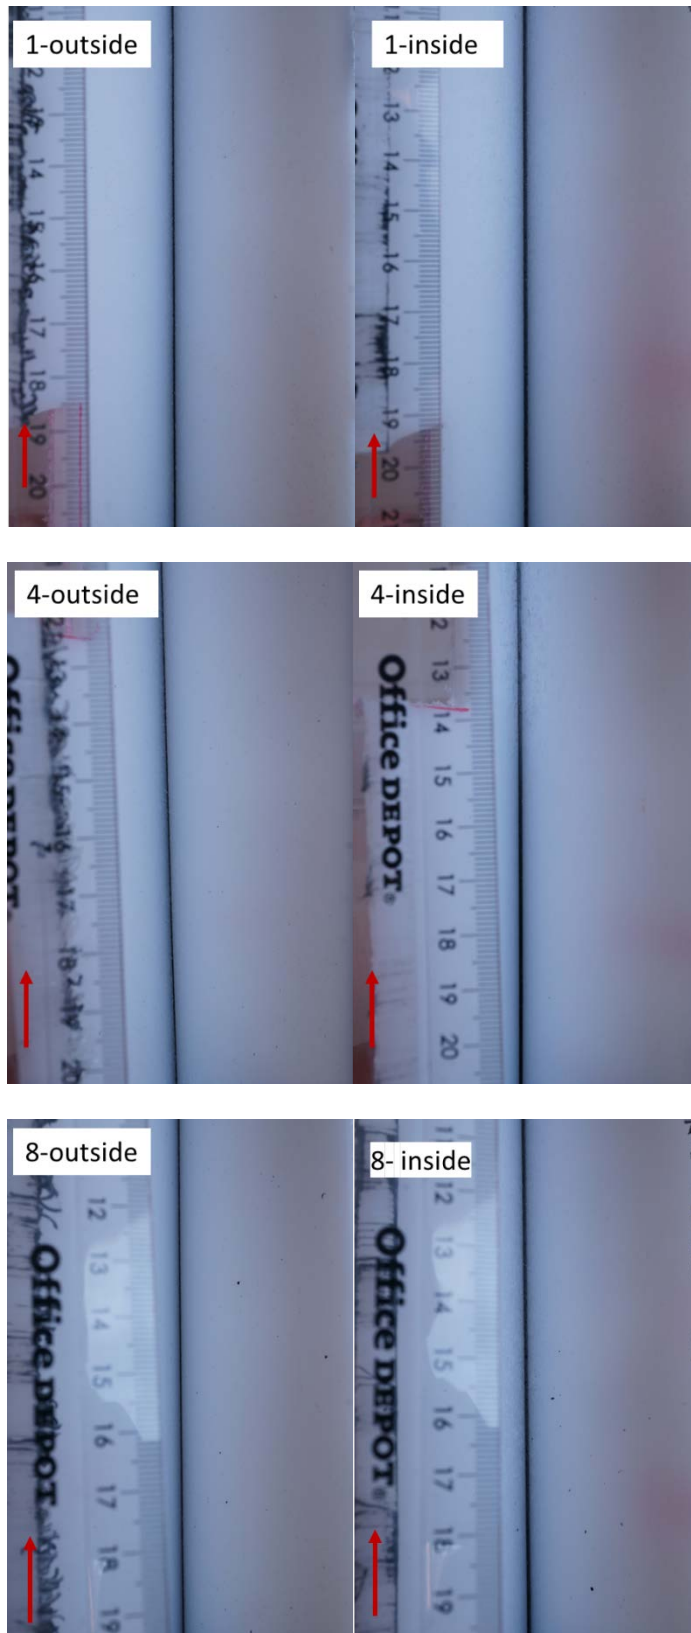
Figure 35: Optical images of individual bend segments 1, 4, and 8 taken from vertical direction. Left: outside half pipe; Right: inside half pipe

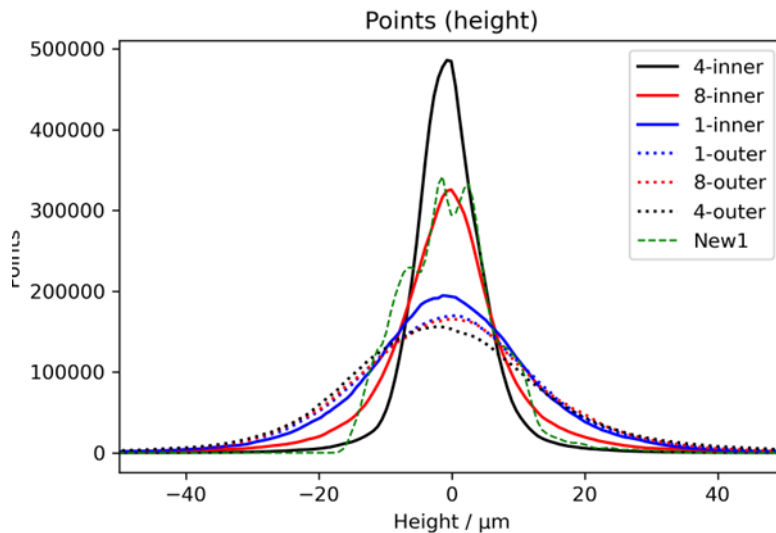
**Figure 37: Height distribution of individual pipe segments**

The roughness of the inner wall was determined by the statistics of the detecting points in the investigated specimens. The dashed line in Figure 37 indicates the height distribution of the inner wall of virgin pipe. It is clear that the inner wall of new pipe is not 100% even, with 3 height peaks corresponding to the stripes along the pipeline induced by the extrusion process.

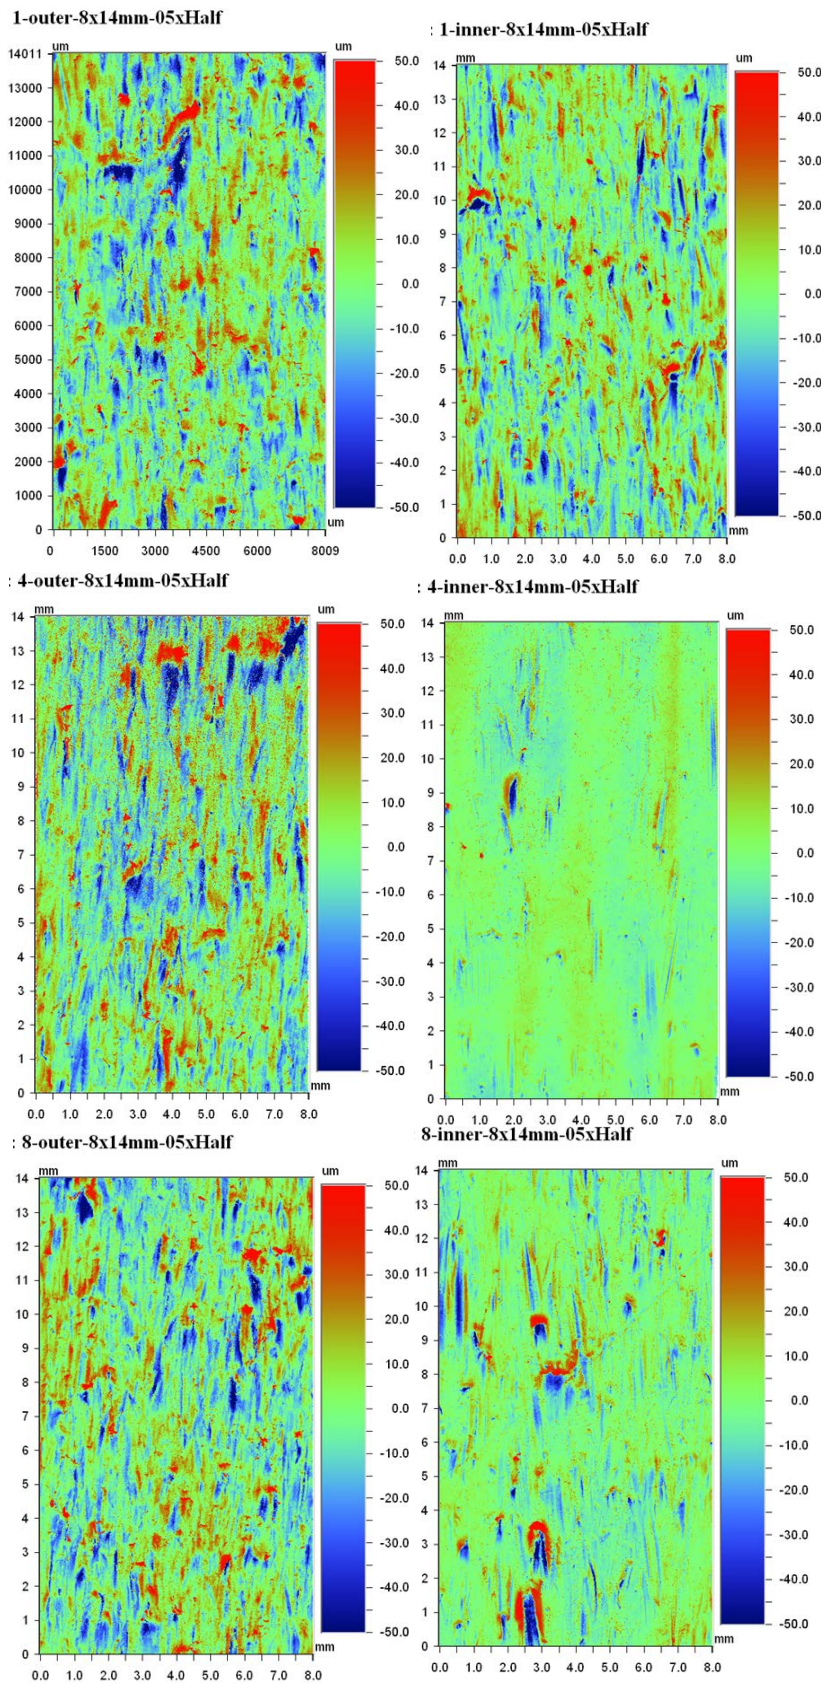
Figure 38: WLI images of inner wall of segments 1, 4 and 8. Left column: outside half pipe; right column: inside half pipe.

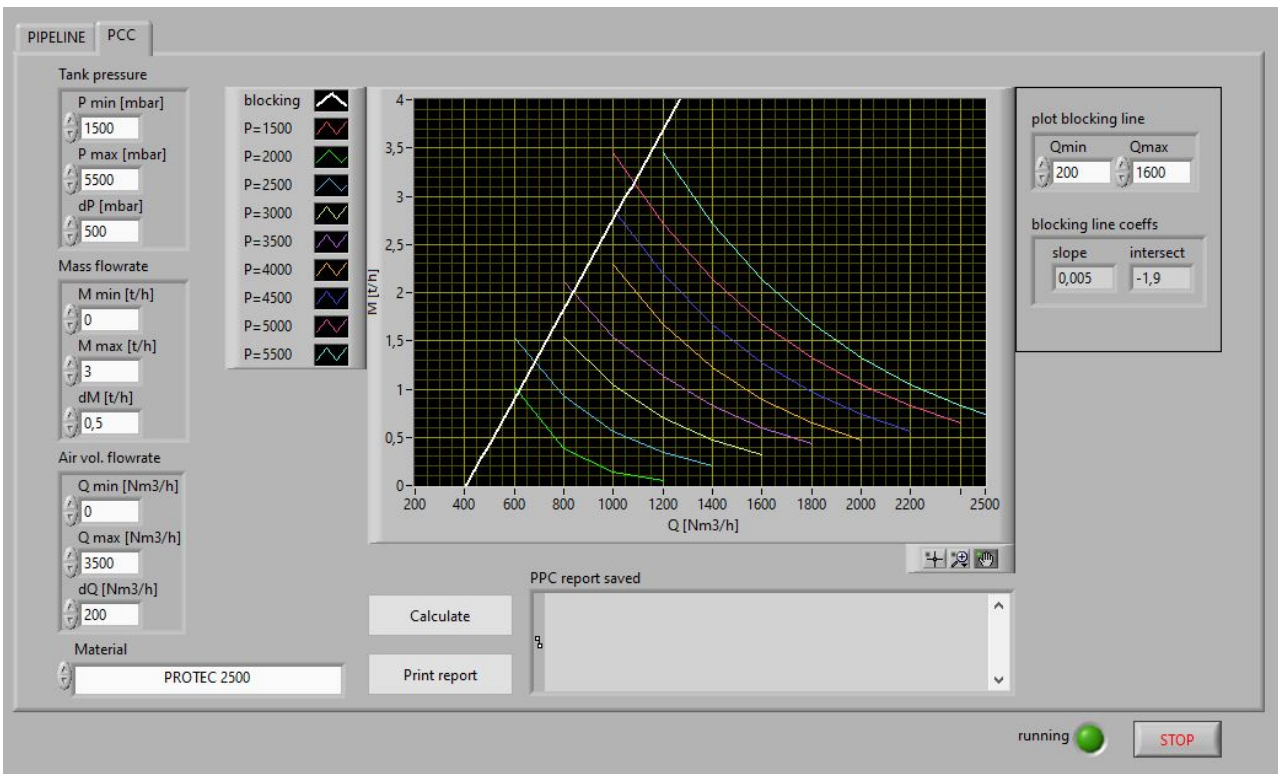
Figure 42: Screenshot of the program showing the pneumatic conveying characteristics (PCC) curves and relevant blocking line
