## Final Project Report- MICRORED

2022:01382 - Unrestricted

FHF - Fiskeri- og havbruksnæringens forskningsfinansiering

Microplastics,  
aquaculture, HDPE  
feeding pipes,  
pneumatic conveying,  
pipe wear, pellet  
degradation

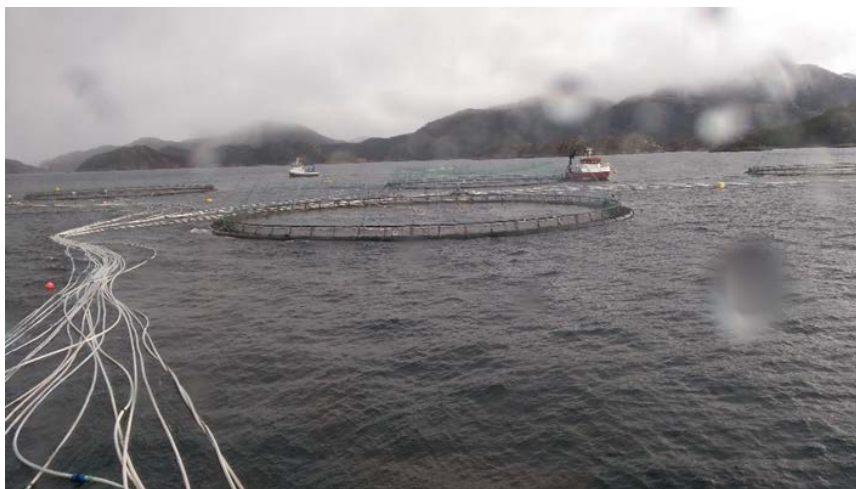
In larger fish farms, the fish feed is typically transported by means of compressed air from the storage point to several fish cages through a network of transportation pipes that are typically made of plastic, mainly HDPE (high-density polyethylene) (Figure 1).

**Figure 1: Centralized feeding system (photo by Chandana Ratnayake).**

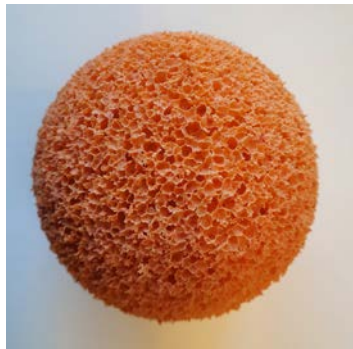
**Figure 7: A cleaning sponge kindly provided by AKVA group for cleaning of feeding pipes.**

As will be shown later, for accurate weight measurements, it is important to ensure that the pipe is clean. The pipe's inner surface can become contaminated by oil and dust from the pellets that are released during the test. To clean the pipe, a mixture of NaOH and KOH (approx. concentration 10-30 wt. %) was used. This was a commercial solution purchased in a local plumber shop for cleaning clogged pipes in households.

Before application, the purchased NaOH/KOH mix was diluted approximately 10 times. After the tests, the bend piece was disconnected from the pipe, fixed in a position (with open ends aiming upwards), filled with the diluted cleaning solution and let stand overnight. The next day the bend was rinsed with plenty of water. To remove the last remains of the pellet residues, a cleaning soft sponge (Figure 7) was pushed through the pipe. After using the ball, the pipe was rinsed with water again and let dry until next day when the weight of the bend piece was taken.

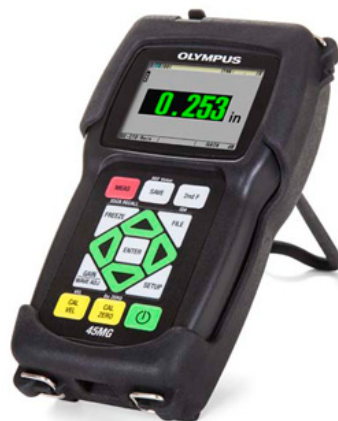
A hand-held device for the measurement of pipe thickness, Olympus 45MG Ultrasonic Thickness Gauge, was used to determine pipe thickness at specific locations along the bend piece where erosion was studied. The instrument has an accuracy of +/- 0.10 mm with a standard resolution of 0,01 mm.

**Figure 8: Olympus 45MG Ultrasonic Thickness Gauge<sup>1</sup>.**

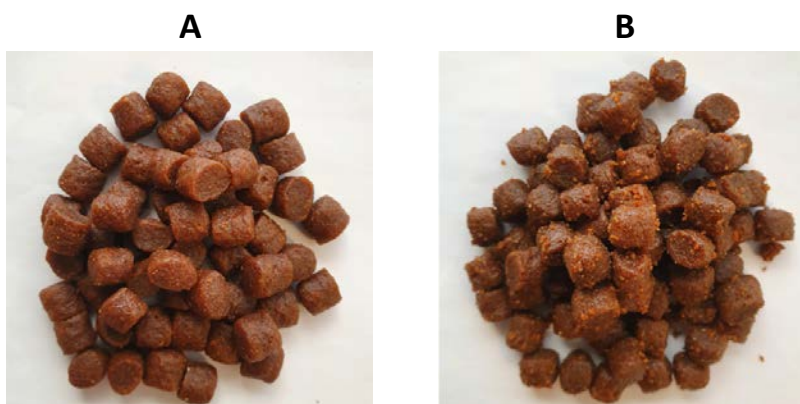
**Figure 12: Photographs of fresh (unused) pellets (A) and used pellets taken out of the pneumatic conveying test rig after finishing all pressure tests (B).**

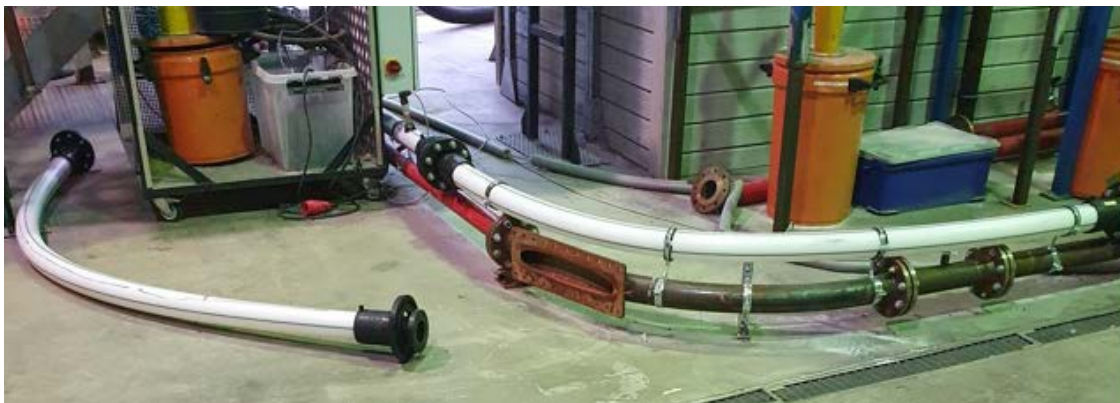
As explained in Section ii, once the pressure tests were finished, the pipeline was opened by cutting out a bend segment (Figure 11A). Flanges were mounted on both sides of the used bend segment and at both ends of the adjacent straight pipe sections so the bend piece could be re-connected with the pipeline. An additional bend segment with flanges was fabricated using a virgin pipe (Figure 13). The detachable bend segments were used in subsequent erosion tests to estimate the degree of erosion during pneumatic transport of fish feed. Pressure transducers are installed before and after the bend to monitor pressure over the bend during the tests.

**Figure 13: Two bend segments with flanges fabricated by Bilfinger.**

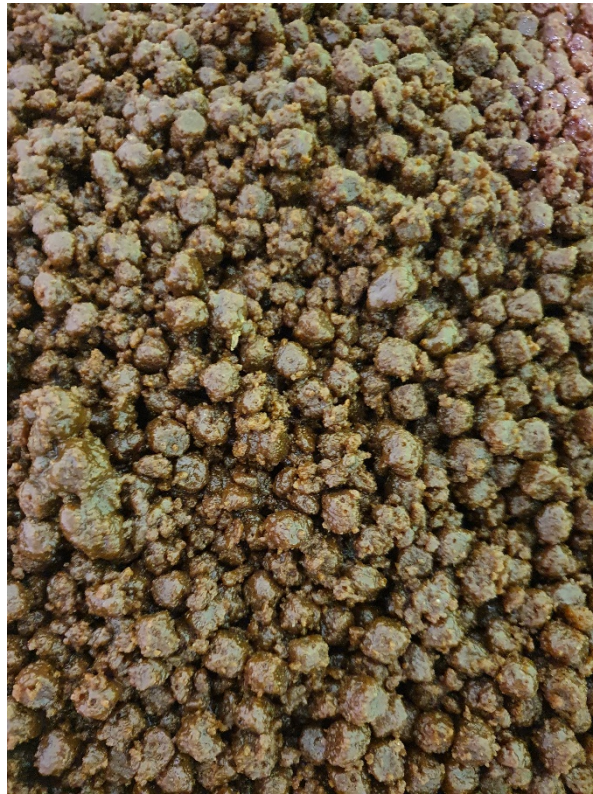
**Figure 16: Degraded pellets after seven rounds of transport in the pneumatic conveying rig, the size of the pellets is reduced, and pellet debris are apparent.**

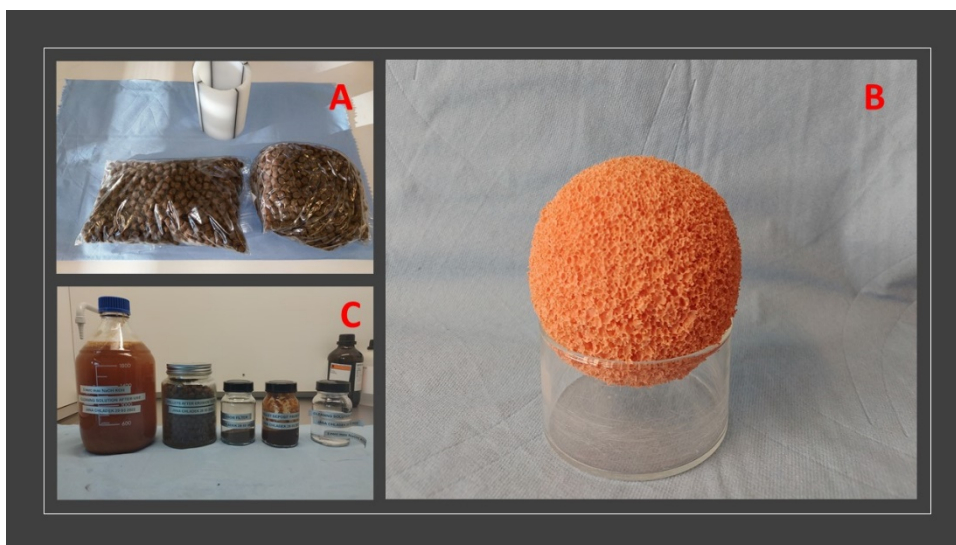
**Figure 20: Testing material received from WP1. A) Pristine fish feed pellets and a sample of the feeding hose used within the convey pilot test; B) Sample of the cleaning sponge kindly provided by AKVA Group; C) samples collected from both different areas in the pellets conveying system and steps in the simulation process.**

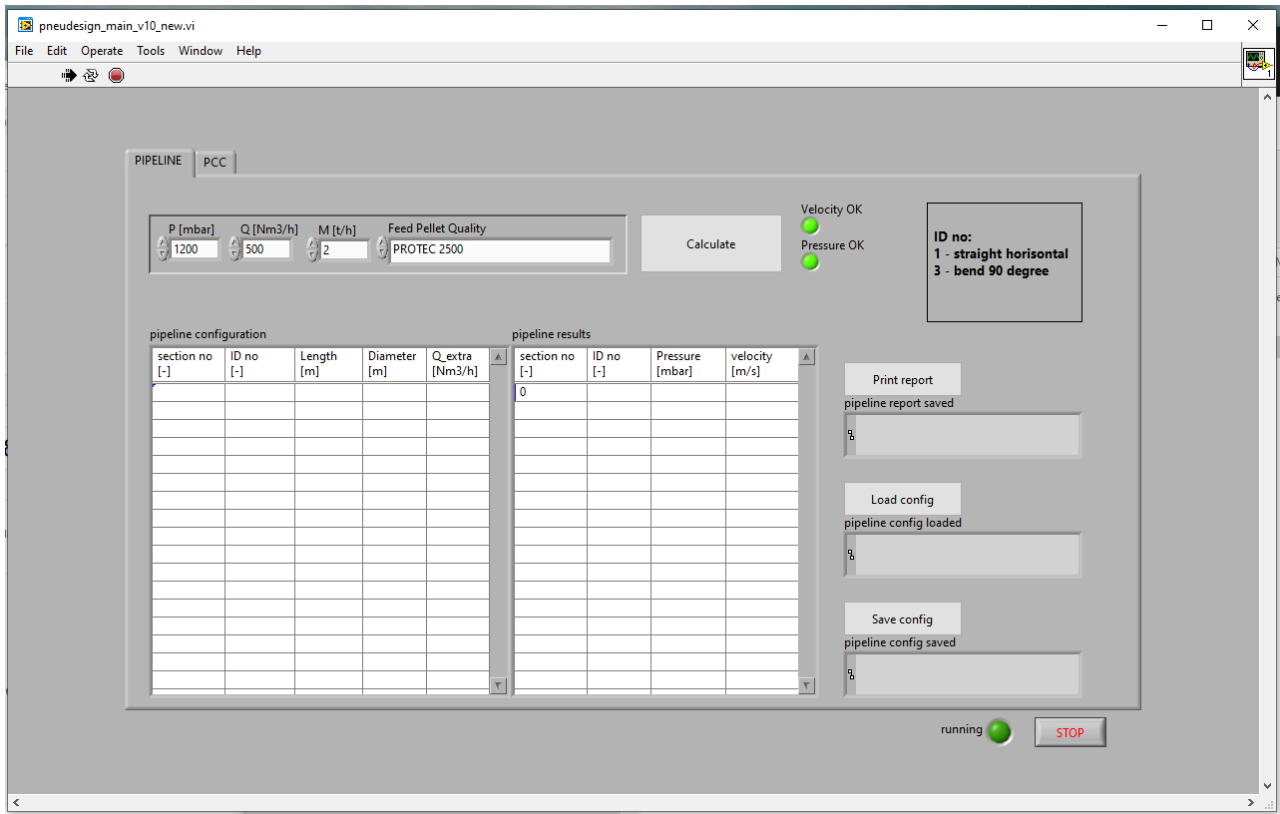
Figure 40: Start screen of the program

The program has two modes of operation: **PLINE** and **PCC**, selected by their respective tabs at the top of the user interface. PLINE must be used to specify the pneumatic conveying line configuration and to investigate the conveying rig performance under a given set of conveying parameters. PCC is used to observe pneumatic conveying characteristic curves for the given pellet type and conveying line. These characteristic curves can be used for optimizing the conveying parameters P, Q, and M for the given conveying line and feed pellet type.
