## Evaluating the efficacy of alternative methods for biofouling control in aquaculture (ALLEGRO)

Prosjektrapport

2018:00733

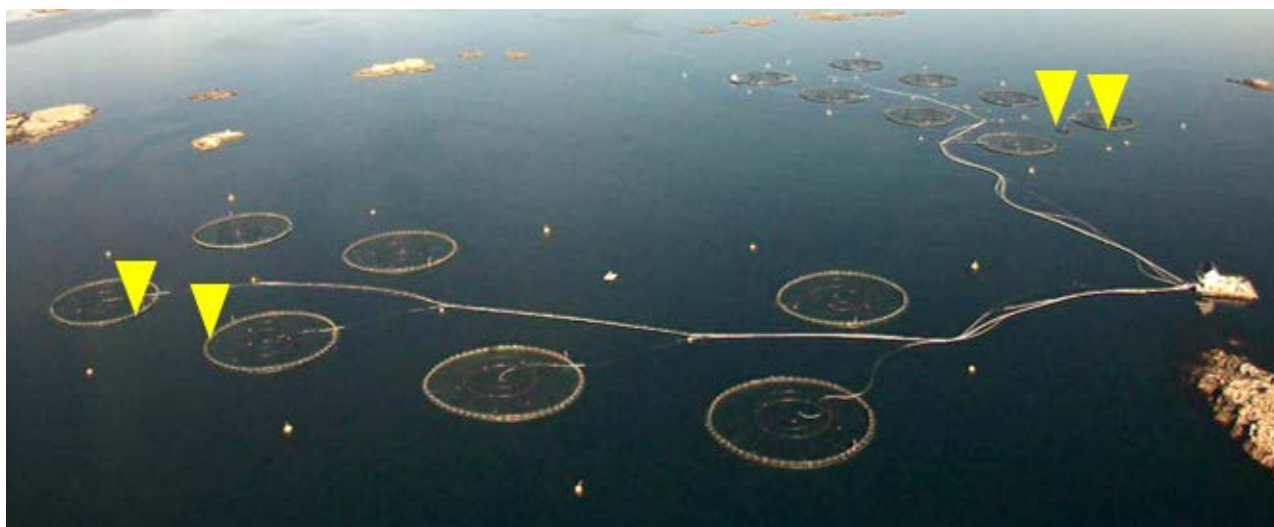
Fig. 1: Yellow markers indicate the four locations of frames holding net and antifouling film samples at the Rataren farm site.

Net samples (20 x 20 cm) were cut from a single piece of net material (Raschel knitt nylon smolt netting, Egersund Net) and mailed to each producer, where they were coated (n = 12 per coating and trial). Each sample was given an individually numbered tag (micro ear tags, OS ID), before they were attached to four metal frames (24 samples per frame) in random order using cable ties (Fig. 1). Each individually marked frame held three replicates of each coating (including controls), with samples placed one sample size apart. The frames were distributed to four locations at SINTEF's research farm site Rataren, Frøya (Fig. 2).

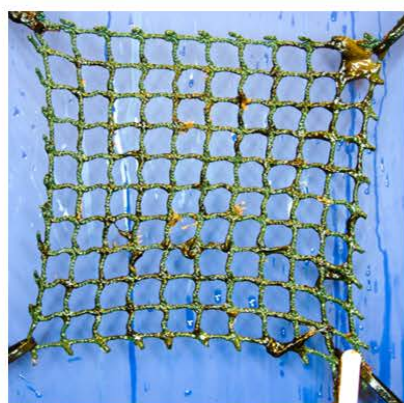
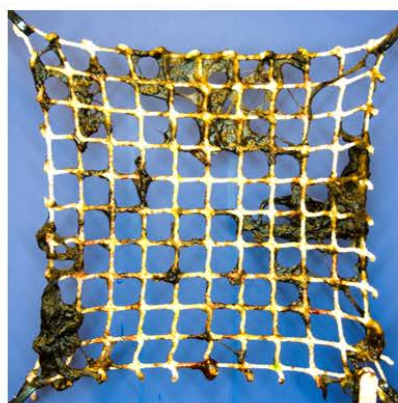
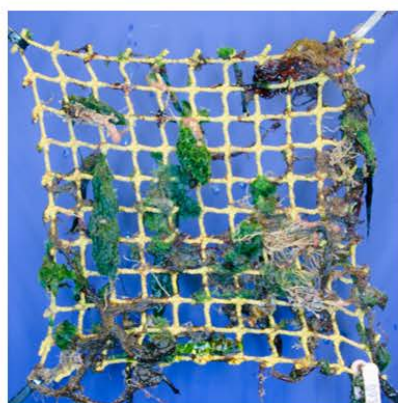
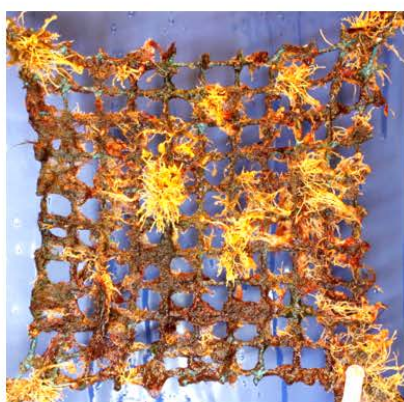
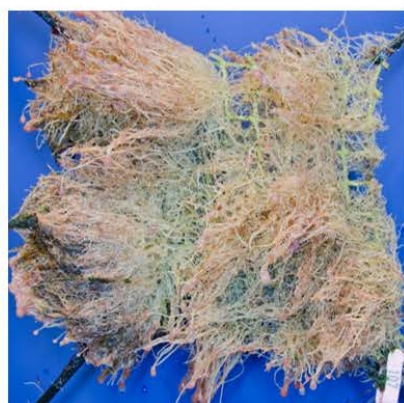
←  
Free  
3 months  
FR: 90  
PNO: 6

←  
Alt 3  
3 months  
FR: 100\*  
PNO: 22\*

←  
Lav 2  
3 months  
FR: 100\*  
PNO: 36\*

←  
Lav 1  
4 months  
FR: 47  
PNO: 51

←  
Alt 2  
5 months  
FR: 0  
PNO: 66

←  
Blank  
3 months  
FR: 0  
PNO: 79

←  
Alt 2  
4 months  
FR: 0  
PNO: 99

**Fig. 3:** Examples of biofouling on net samples, with information on Fouling resistance (FR) and Percentage Net-aperture occlusion (PNO). An asterisk indicates samples where discrepancy between FR and PNO occurred due to the presence of dead material that was excluded in the FR measurement.

The monthly pictures of the net samples were analysed using two methods: (i) Percentage Net-aperture Occlusion (PNO), which calculates the total contribution of biofouling to the occlusion of the net aperture, was measured using a method described in Guenther et al. (2010). Using this scale, a PNO value of 50 applies to net samples where 50 % of the net aperture is obstructed by biofouling, potentially hindering water flow through. (ii) Fouling Resistance (FR) was measured according to the ASTM standard (American Society for Testing and Materials ASTM 1998), modified to evaluate nets. Using this scale to evaluate the biofouling organisms found on the actual net, a FR value of 100 describes a surface free of fouling, whereas FR=50 applies to surfaces half covered in biofouling. The analysis was based on the identification of taxonomic groups at 66 points on the net, defined by the intersection of the net with 3 randomly placed vertical and horizontal lines. Slimes and algal spores <3 mm were not counted as fouling (FR score = 100 even in their presence), while the presence of larger fouling organisms resulted in a default reduction of the FR score to 95, or lower depending on fouling abundance (American Society for Testing and Materials ASTM 1998). Clearly identifiable dead algal material that had drifted into the net was excluded from the FR analysis. It was not possible to exclude this material from the PNO analysis (Fig. 3).

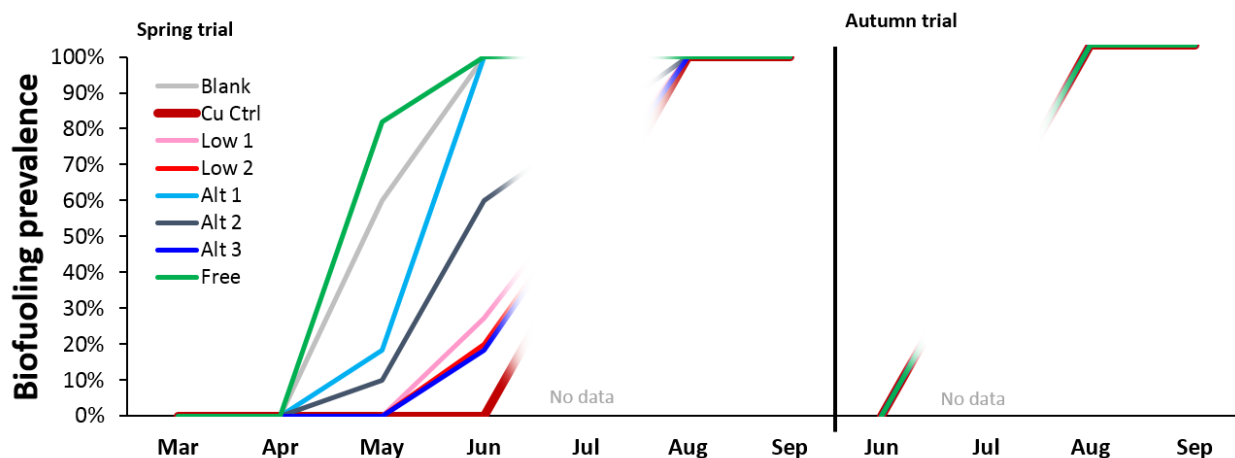
**Fig. 4:** Prevalence of biofouling on net samples treated with 8 different coatings in the spring (6 months duration) and an autumn (3 months duration) trial.

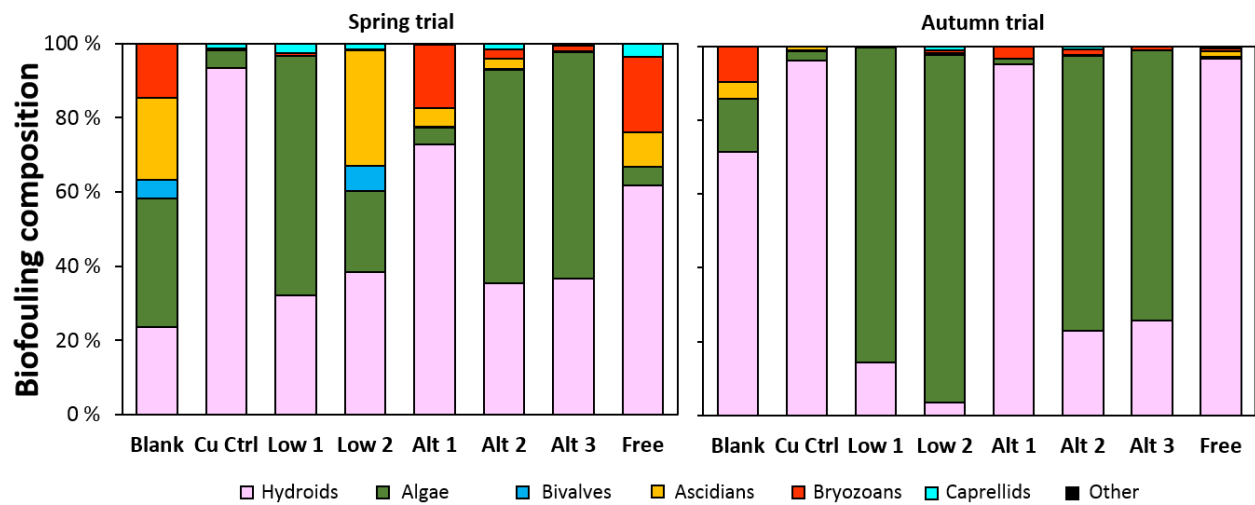
**Fig. 9:** Total biofouling composition on nets with 8 different coatings after 6 months (spring trial) and 3 months (autumn trial) at sea, depicting percentage cover of hydroids, algae, bivalves, ascidians, bryozoans and caprellids.

dominated by hydroids in both trials. The only other species on the copper coated samples were algae and caprellid amphipods (Figs. 9 and 10).

Species richness was low on the biocide free coating in both trials for most of the time, but increased towards the last month of both trials (Fig. 8). The main biofouling species on the biocide free coating were hydroids, with exception of the September samples of the spring trial, where bryozoans made up almost 50 % of the fouling species, in addition to ascidians, caprellid amphipods and algae (Figs. 9 and 10).

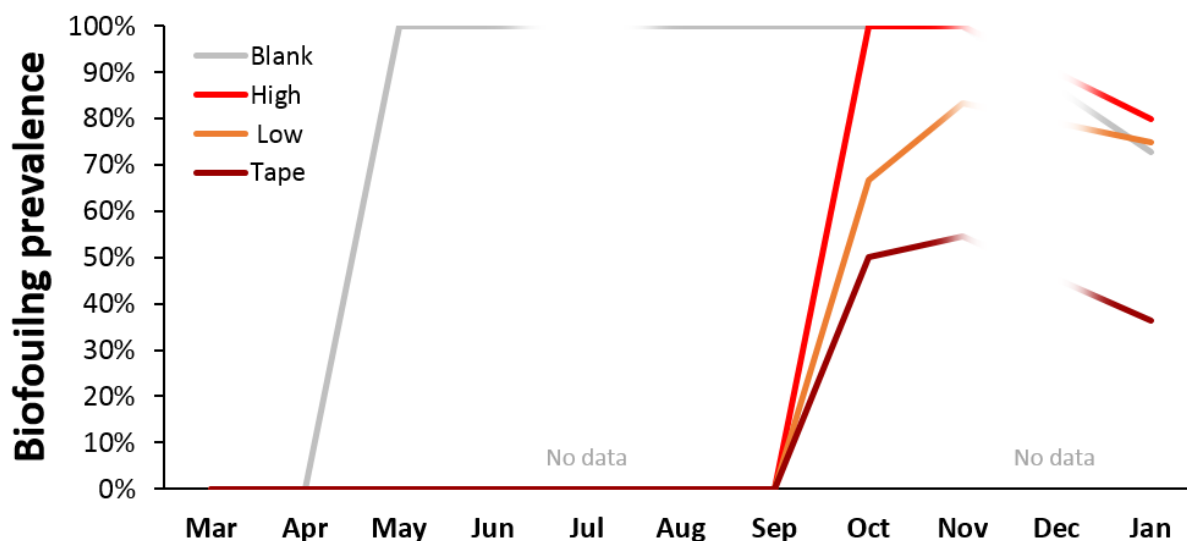
Fig. 11: Prevalence of biofouling on 4 tested surfaces during a 10 months trial.

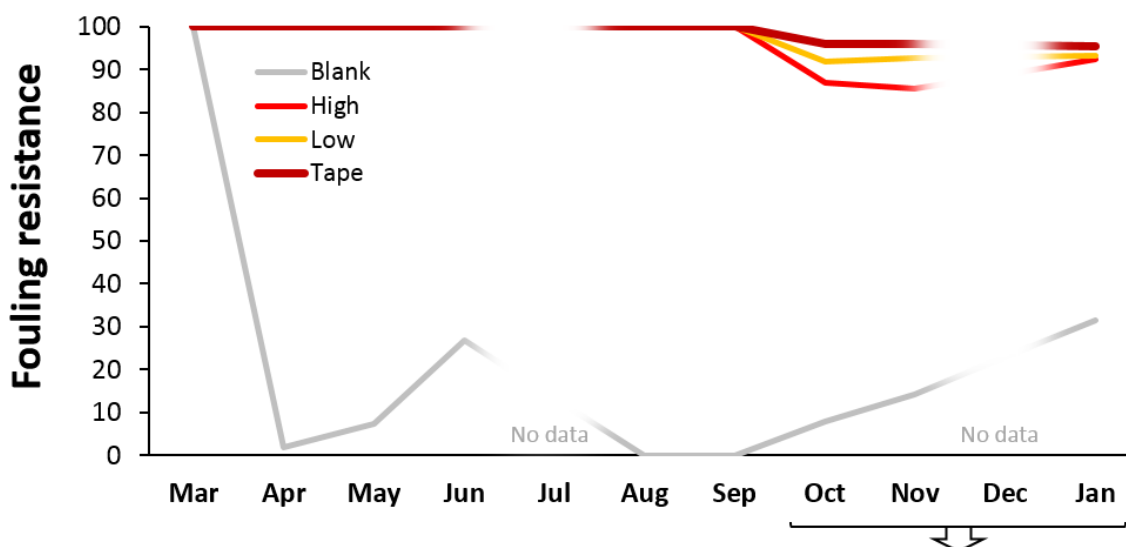
Fig. 12: Fouling resistance of 4 tested surfaces during a 10 months trial, with a detailed depiction of the three antifouling films in the last months of the trial.

Fouling resistance of the blank samples was 0 after one month at sea and varied slightly after (Fig. 12). Fouling resistance of the antifouling samples was 100 until October (7 months after immersion), from where it decreased. There was no significant difference in the performance of three antifouling films. Fouling resistance did, however, vary to some degree between immersion time and locations (Time x Location:  $F_{6,83} = 2.78$ ;  $p = 0.0173$ ).

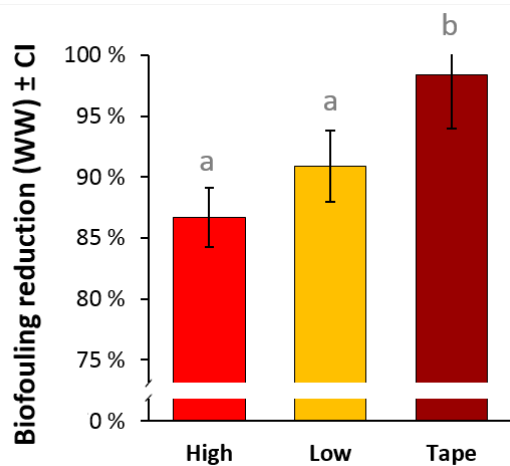
**Figure 13:** Biofouling wet weight (WW) reduction relative to the uncoated control samples (average  $\pm$  CI), measured on panels with 3 different coatings. Lower case letters indicate statistically significant differences.

After 10 months of immersion, the blank control panels had gained most weight with an average of 59 g. Although the differences were not very large, the copper shim tape prevented significantly more weight accumulation than the embedded copper films (Coating:  $F_{2,30} = 14.60$ ,  $p < 0.001$ ; pairwise comparison,  $p < 0.05$ ; Fig. 13).

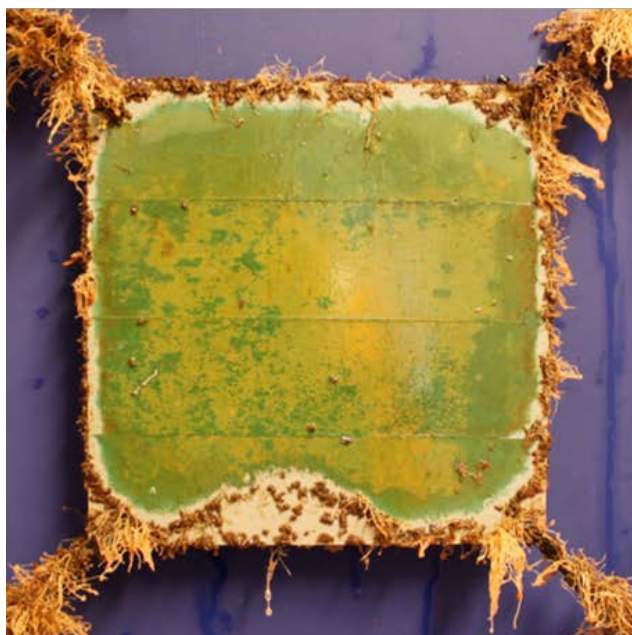
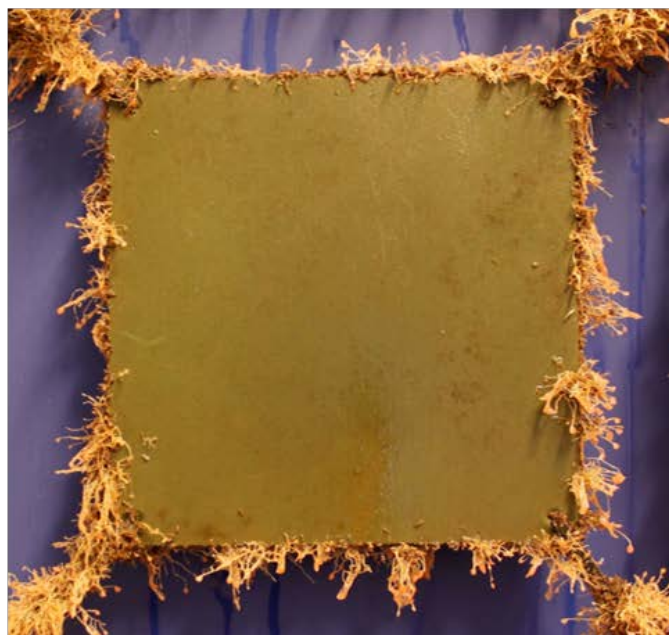
**Figure 14:** Left: Example of a PVC panel coated with copper shim tape (green/yellow). Where the copper has leached out, the grey PVC base plate can be seen. Right: In comparison, no patchy leaching is visible from the copper-embedded antifouling film.

On the copper shim tape, the leaching of copper was visible through the loss of colour of the tape, showing the PVC panel below the transparent layer of adhesive (Fig. 14). On average, 16 % of the visible copper surface was lost from the tape panels by the end of the 10-month trial. No copper loss was visible from the films embedded with copper particles.
